SUBJECT: AIR DISPERSION MODELING ANALYSIS OF PRIORITY INCIDENT 38-MON-05

I. Background

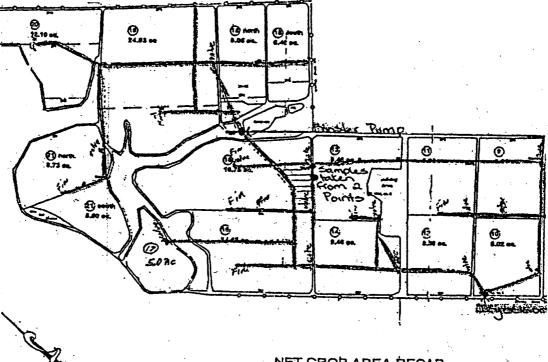
Figure 1. Diagram of individual blocks at Duncan Ranch/Daren's Berries Site. Priority Investigation 38-MON-05.

Block 20 is the section farthest to the north and east of the agricultural parcel that is partitioned into 20 separate sections (Figure 1). Although throughout the investigation report Block 20 is referred to as 13 acres in size, the diagram showing the blocks labels Block 20 as 12.1 acres. Confirmation that Block 20 was the 12.1 acre treated site was received from Karen Stahlman of the Department Pesticide Regulation's (DPR's) Enforcement Branch (per. comm.). Block 20 was modeled as a polygon. Universal Transverse Mercator (UTM) coordinates around the perimeter of the block were obtained from ArcView software (ESRI, Inc.). Weather data used in the modeling is shown in Table 1. The generic input file used for modeling is available in Appendix A.
