MEMORANDUM

HSM-09008

SUBJECT: OBSERVATIONS AND RECOMMENDATIONS FROM A WORKPLACE
EVALUATION OF TWO FUMIGATION FACILITIES IN THE LONG BEACH
AREA, LOS ANGELES COUNTY ON JULY 7, 2009

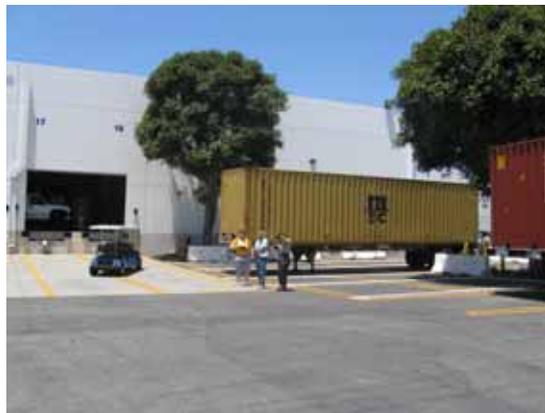
Figure One: Building Four Intermodal Site

The first facility visited, located at the PriceTransfer company property in Long Beach, presently conduct outdoor tarpaulin fumigation of intermodal vans. The location of this fumigation was such that buffer zones would intrude into structures where workers would be present. This results in non-compliance with the "Suggested Permit Conditions: Methyl Bromide (MeBr) Commodity Fumigation" Permit Conditions concerning Definition R/Condition 19: Treatment Zone Access and Duration. The facility manager proposed moving the fumigation site to an alternate location, adjacent to a structure identified as "Building Four" (see Figure One) where two of the rollup doors could be left down.

This was still not deemed suitable, since depending on the number of intermodals and the rate of application, the buffer zones could extend far enough to reach rollups on the adjoining building that could not be left closed. However, the facility manager was supportive of the idea of equipping the affected structure with real time MeBr monitoring equipment; such as, but not necessarily limited to, the Pure Aire “Air Check Advantage Methyl Bromide Monitor.” The manufacturer of this monitor has stated that they can achieve detection limits of 500 parts per billion (ppb). The facility manager stated that his company would be willing to deploy and maintain such a system in Building Four if this would allow intermodals to be tarp-fumigated by the structure.

OPTION ONE FOR BUILDING FOUR: If the outdoor tarped/intermodal fumigation site is to be moved to the Building Four location, the rollup doors that lie within the buffer zones of the fumigation and aeration must be latched and locked down for the duration of the fumigation and aeration. Any exit doors that would lie within the fumigation and aeration buffer zones must be equipped with emergency alarms and be designated "EMERGENCY EXIT ONLY" during the fumigation and aeration buffer zones. Do not chain off or otherwise render inoperable any exit door.

OPTION TWO FOR BUILDING FOUR: If a real-time air monitoring system, specific for MeBr, is installed in Building Four, only the two rollup doors closest to the fumigation and aeration need be latched and locked. Deployment of the detector's sensors should be such that they are not unduly affected by outside air (i.e., not right next to openings to the exterior) and that they are located in areas that an intruding buffer zone would be located. This monitoring system will need to be maintained and calibrated according to the manufacturer's recommendations and be capable of data logging, recording at a minimum of 5 minute intervals during fumigation and aeration events. When there are no fumigations or aerations, logging may be suspended. The data logs must be available for CAC inspection and a hard copy maintained for 3 years. Exit doors that are immediately adjacent to the latched and locked rollups should be equipped with emergency alarms and designated "EMERGENCY EXIT ONLY" during the fumigation and aeration buffer zones. Do not chain off or otherwise render inoperable any exit door.

OPTION THREE FOR BUILDING FOUR: All fumigation and aeration work performed when all non-application workers are not present (e.g. weekends or nights).

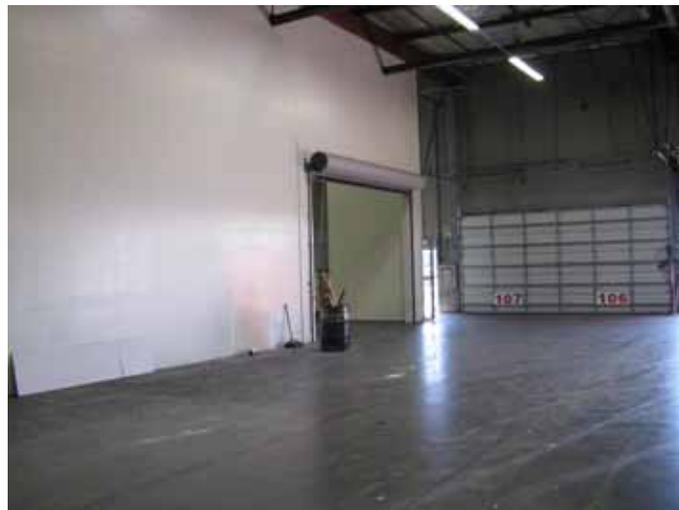
Figure Two: Building Three Interior NPF Wall

The second fumigation issue, also at the PriceTransfer location, is the potential conversion of a warehouse (Building Three) into a negative pressure facility (NPF). The NPF site would be enclosed on two sides by the original warehouse exterior walls and on the other two sides by interior walls recently added in anticipation of use as a fumigation site. It is presently in non-compliance with MeBr Permit Conditions; Condition Four: Common Walls (see Figure Two for picture of wall separating fumigation area from the rest of the structure). The NPF fumigation site would not be a chamber proper, but an enclosure for tarpaulin-covered intermodal fumigations. This is along the same lines as the existing NPF presently operated by Clark Pest Control in Long Beach. According to the facility manager, the site can be retrofitted to allow for use as a NPF. There is also the option of fumigation/aeration when workers are not present (night or weekend fumigation).

OPTION ONE FOR BUILDING THREE: Conducting all fumigations and aerations during periods when no workers are present in the structure or working in buffer zone areas would allow for fumigation to be done with little to no modifications. Compliance with the basic requirements of the MeBr Permit Conditions would be necessary, but no further efforts would be required.

OPTION TWO FOR BUILDING THREE: The structure may be modified into a NPF. Preliminary work by the facility manager appears to set up the framework for conversion of the structure into a negative pressure facility. If this route is taken, the following actions are required:

1. Seal airtight all penetrations, including power outlets, breaker boxes, switch boxes, door gaps, etc.
2. Contract with a ventilation engineer to design a system with adequate capacity to maintain negative pressure (≥ 0.1 inches of water) sufficient to prevent any outward leakage of fugitive emissions from the tarped intermodals. The engineer should confer with Worker Health and Safety (WHS) Branch for guidance.

3. Only tarped intermodal or tarped stack fumigations are allowed. An NPF is not a fumigation chamber.
4. Install louvered air intakes along the outside walls, which are open during negative pressure activity, but automatically close during zero air flow or reversed (positive pressure) air flow. Circulatory fans may also be necessary to prevent any "dead" air pockets.

5. Roof fan located outside of negative pressure site shall be fully on, in positive pressure mode (blowing fresh air into the remainder of the structure that is not the negative pressure portion) during any fumigations and aerations.

6. An exhaust stack of sufficient height shall be installed. Do not situate such that the roof fan mentioned in Point 5 recaptures the exhaust air and sends it back into the general facilities air space.

7. A gauge (e.g. Magnehelic) shall be installed outside the negative pressure area to confirm system operation. Optionally, an alarm may also be installed to indicate ventilation failure.

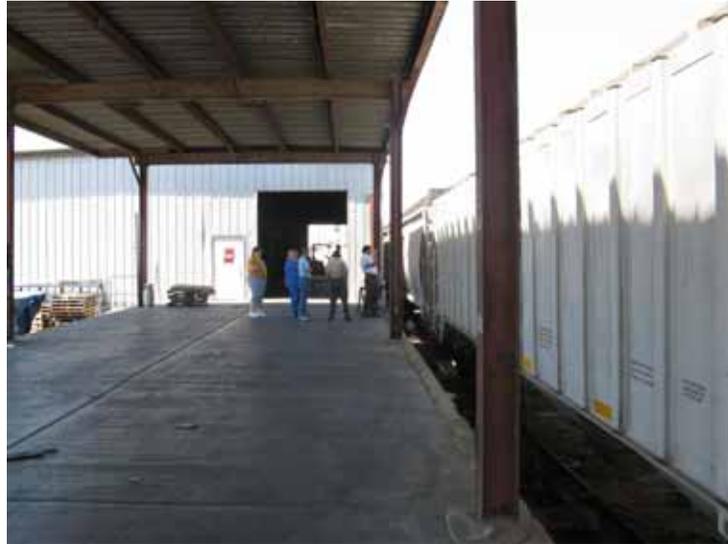
Figure Three: San Pedro Forklift Load Dock and Fumigation Structure

The third fumigation issue dealt with a smaller facility called San Pedro Forklift. This facility was using two metal structures (not gas tight), connected by a 300 foot loading bay area (see Figure Three).

Since both structures are in close proximity, their buffer zones are calculated from a combination of both MeBr application loads. This results in the buffer zone extending beyond the facilities fence-line and into the adjoining property, where idling tractor-trailers, with drivers, are awaiting to unload their loads (Figure Four) and also extending to the air handlers/doors of the “portable” office structure (Figure Five). Note that “buffer zone exclusion tape” includes the office.

discussed the buffer zone problems with the CAC staff. When the manager mentioned the idea of converting the existing metal structures to NPFs, I'd cautioned against such a conversion. The sheet metal structures were in some disrepair and were riddled with penetrations. Simply attempting to plug the obvious penetrations and install a negative pressure system would likely result in a distorted or collapsing structure.

There appear to be no useful engineering or administrative controls available beyond those listed in the MeBr Permit Conditions. The enclosing structures are of doubtful gas tightness and even less structural capability as negative pressure facilities. The movement of the office trailer out of the buffer zones should be completed as soon as possible, with evacuation of the trailer during fumigation and aeration as an interim solution.

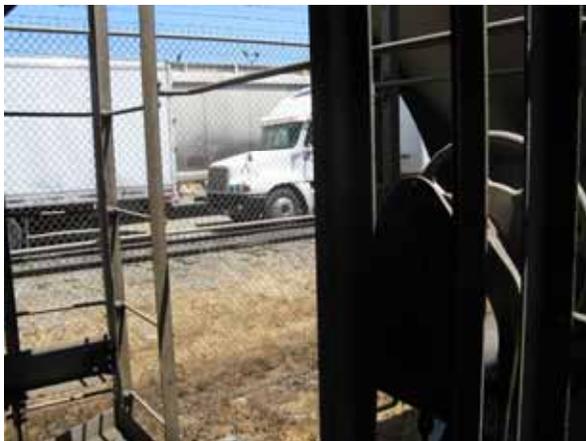
Figure Four: Trucks Potentially in Buffer Zones

The off-property extension of the buffer zone results in non-compliance with Definition R, Condition 19; Treatment Zone Access and Duration of the MeBr Permit Conditions. While we were conducting the workplace evaluation of the facility, the facility manager arrived and
